UNDERWATER FACILITIES
INSPECTION AND ASSESSMENT

DEPERMING FACILITY
U.S. NAVAL STATION
NORFOLK, VIRGINIA

FPO-1-81-(16)

July 1981

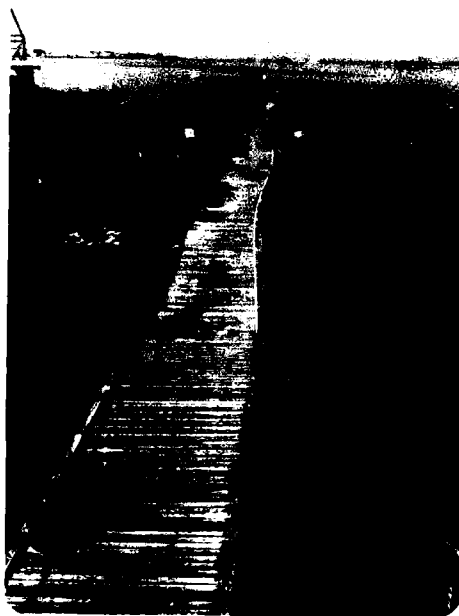
PHOTOGRAPH 2

Pier C. Note deperming berth for submarines and small craft in berth to right and larger berth left. Also note impact deflections of Pier C.
